Transport simulation on Metal drums - Cordstrap CC65 and CB6S – Drumclip DC18A RED

Test Report IPS8858-80 | ISTA-3E2017

Internal Doc ID#: IPS8858-80

Project name: Transport simulation on metal drums - Cordstrap CC65 and CB6S - 2x Drumclips DC18A RED

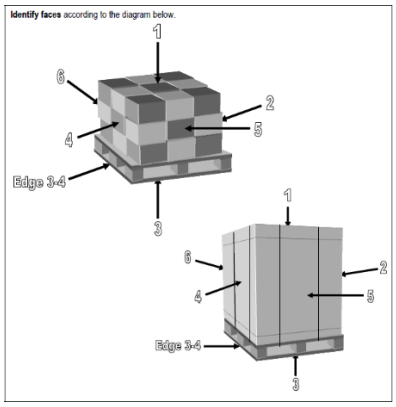
Package as received

Product Condition	Drums have some dents. Pallet is undamaged. Drumclips and Cordstraps are new and installed after arrival at IPS testlab.
Packaging Condition before testing	NEW re-packaged with new materials before testing.
Additional Notes	Re-strapping is done by Geba employee with appropriate tools, conform packaging guidelines of Geba.

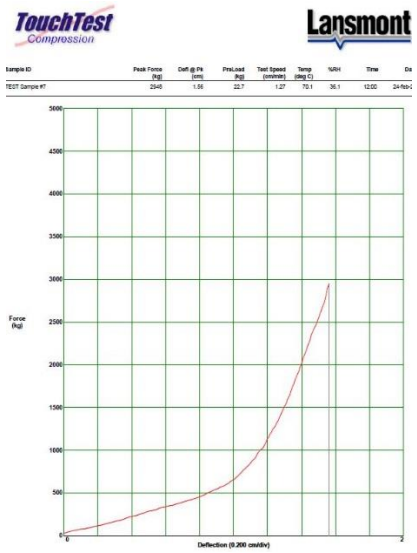
Test setup

The test is performed with a pallet on top of the packet pallet. This is done in order to simulate a stacking load "footprint" of similar packed pallets.
The package withstood the compression test without problems.
